**Final Report**

**NASA NAS5-22961**

**Schwar~~X~~schild Camera**

(NASA-CR-160061) SCHWARZSCHILD CAMERA  
Final Report (Space Optics Research Labs.,  
Inc.) 14 p HC A02/MF A01 CSDL 20F

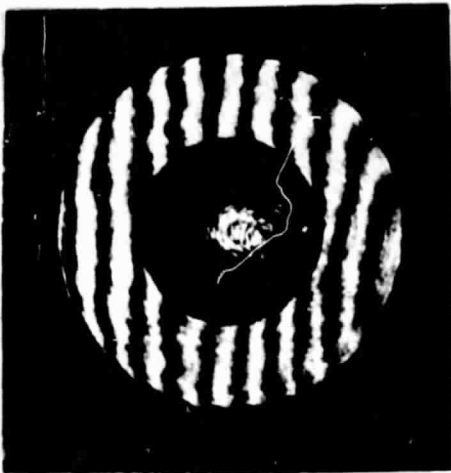
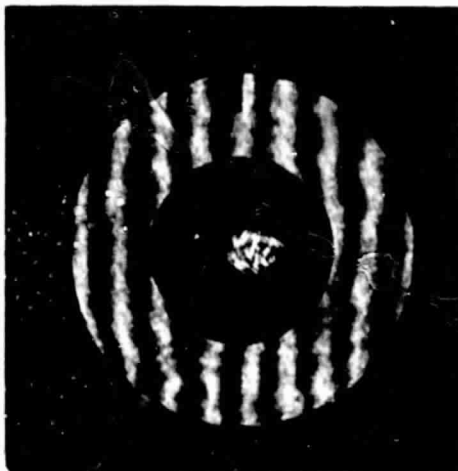
Figure 1

During the rework, the secondary mirror was found to have about  $1/2$  wave of asymmetry. This was discovered by studying a series of interferograms in which the mirror was rotated versus the null lens. Figures 1 and 2 show a series of 3 pairs of interferograms made after the mirror was corrected. The resultant asymmetry and figuring zones would be approximately  $1/8$  wave peak to peak error on the mirror surface.

Secondary Mirror

in LUPI Test

Null Lens Rotated by 120°

This asymmetry probably arose in the beginning due to unbalanced hand figuring and slight miss alignment of the null lens test set up. It was corrected by spinning the mirror against a large, full sized fixed lap and by locally figuring selected areas of the mirror. We reached a point where it was uncertain if this mirror was asymmetric, the null lens asymmetric, or the test alignment slightly out. At this

level of accuracy, about  $1/8$  wave, the opticians result began to oscillate from good to bad and back. Some proportion of the  $1/8$  wave error visible in the interferograms is in the mirror. There will undoubtedly be a resulting asymmetry in the off-axis resolution. The magnitude of this effect is impossible to predict based on our data.

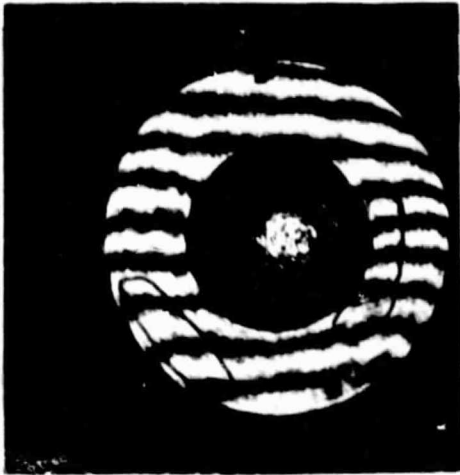
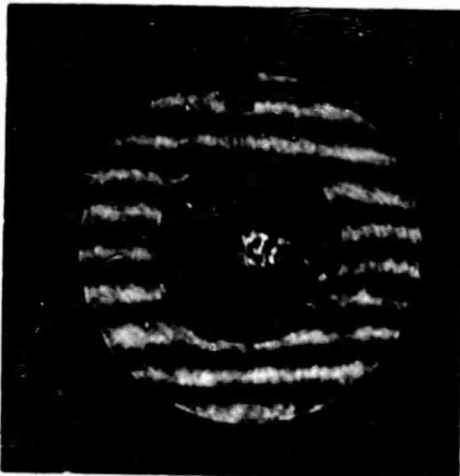
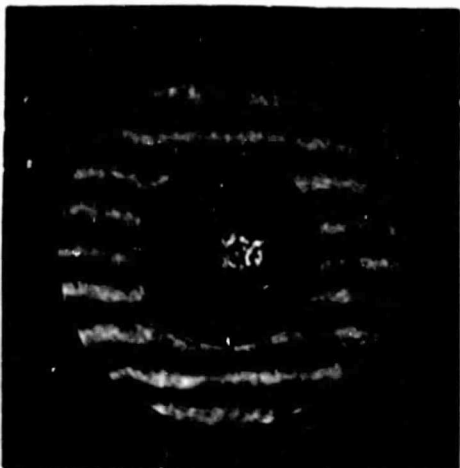
Figure 2

Secondary Mirror in  
LUPI Test

Null Lens Rotated by 120°

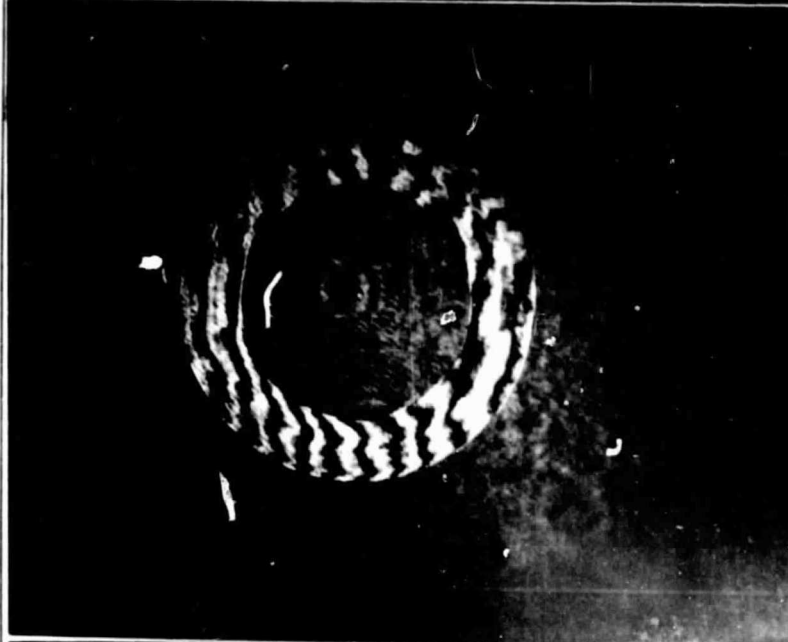
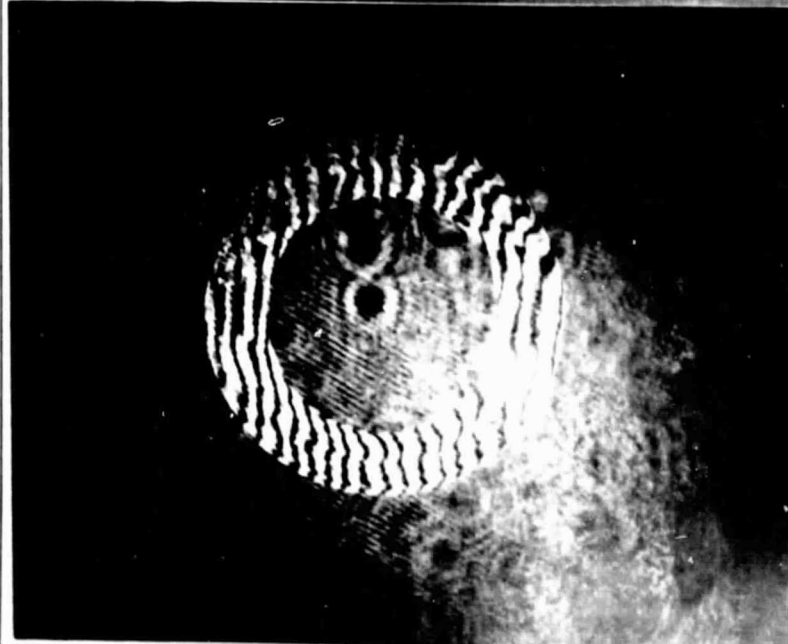
Figure 3

Interferograms of the primary and secondary mirror as a system are shown in Figure 3. The system is double passed so that a fringe of error represents  $1/2$  wave, wavefront error. The system has  $1/2$  wave peak to peak error at .63 microns.

Double Pass Interferogram  
@ .63 microns of System
